Measure Rebar Cover with Maximum Precision

Profometer PM8000
Cover Meters

New Neighbouring Rebar Correction (NRC)

Master rebar cover inspection of curved elements

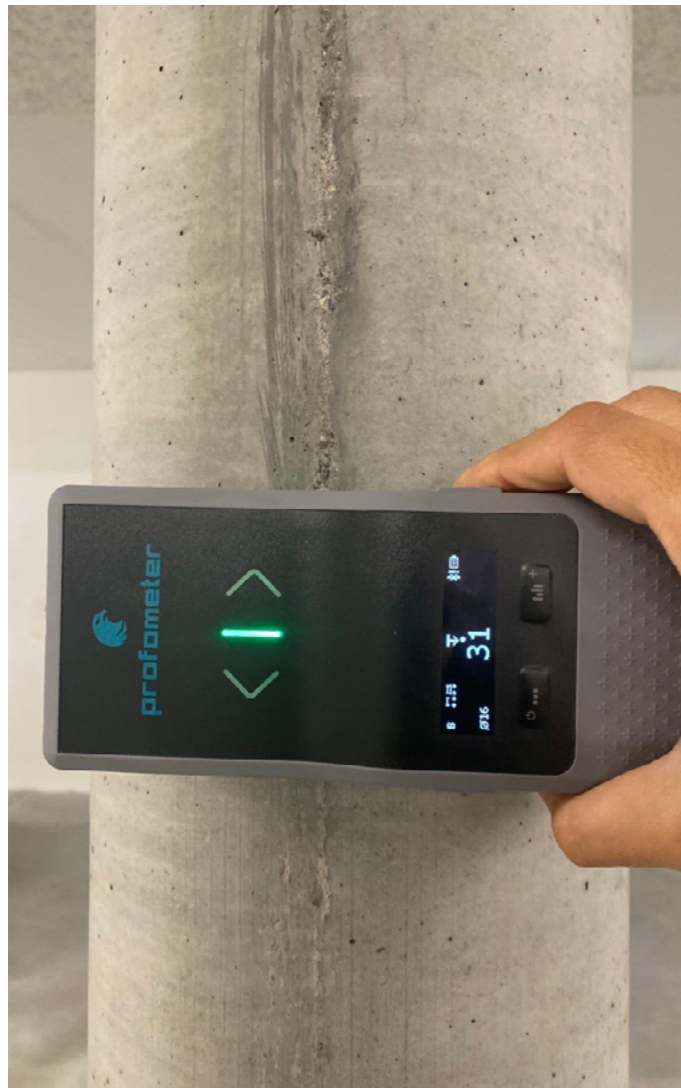
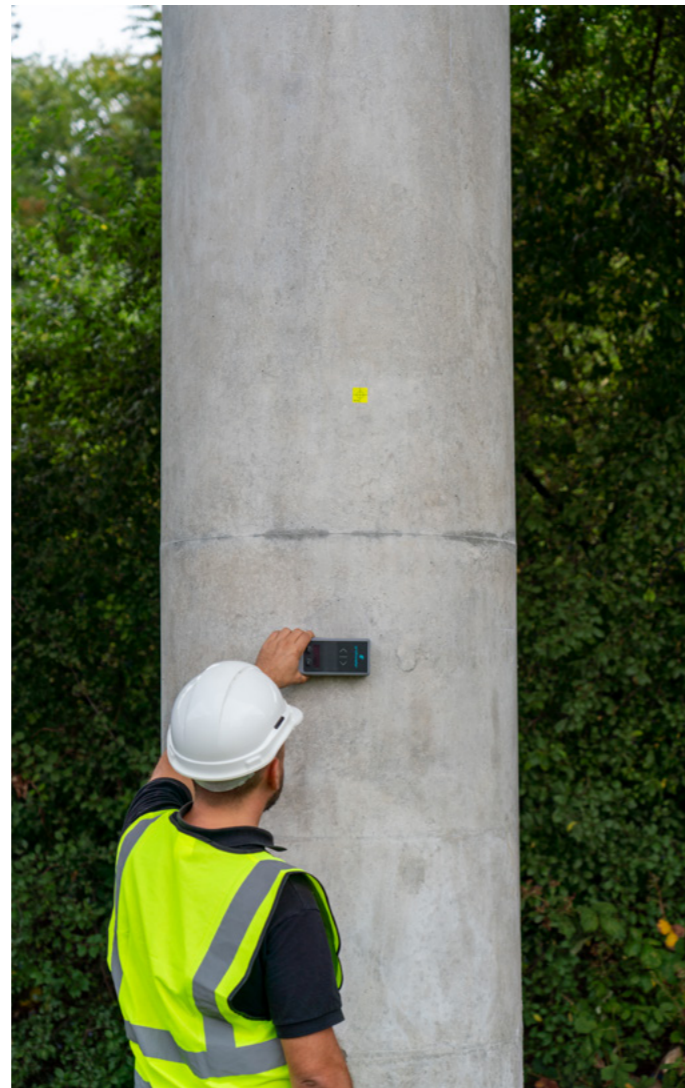
How to scan 1st layer rebar using the PM8000

To measure the 1st layer rebar called ties, place the PM8000 in mid-position (between two longitudinal 2nd layer rebar) on the concrete surface as shown in the image, and move it slowly, sweeping parallel to the ties 1st layer rebars. The strongest signal results are obtained when the vertical axis is parallel to the rebar being measured and the measurement center is directly over the rebar.

Used as a standalone device without the iPad or wheels, the PM8000 Lite makes the ideal solution for this application. The Neighbouring Rebar Correction automatically factors in the influence from the 2nd layer rebar, giving you accurate results every time.
